Important Safety Notice: Solenoid Coil Identification

⚠️⚡ DANGER: SHUT-OFF POWER TO THE UV SYSTEM PRIOR TO INSPECTING THE COILS TO PREVENT RISK OF SHOCK

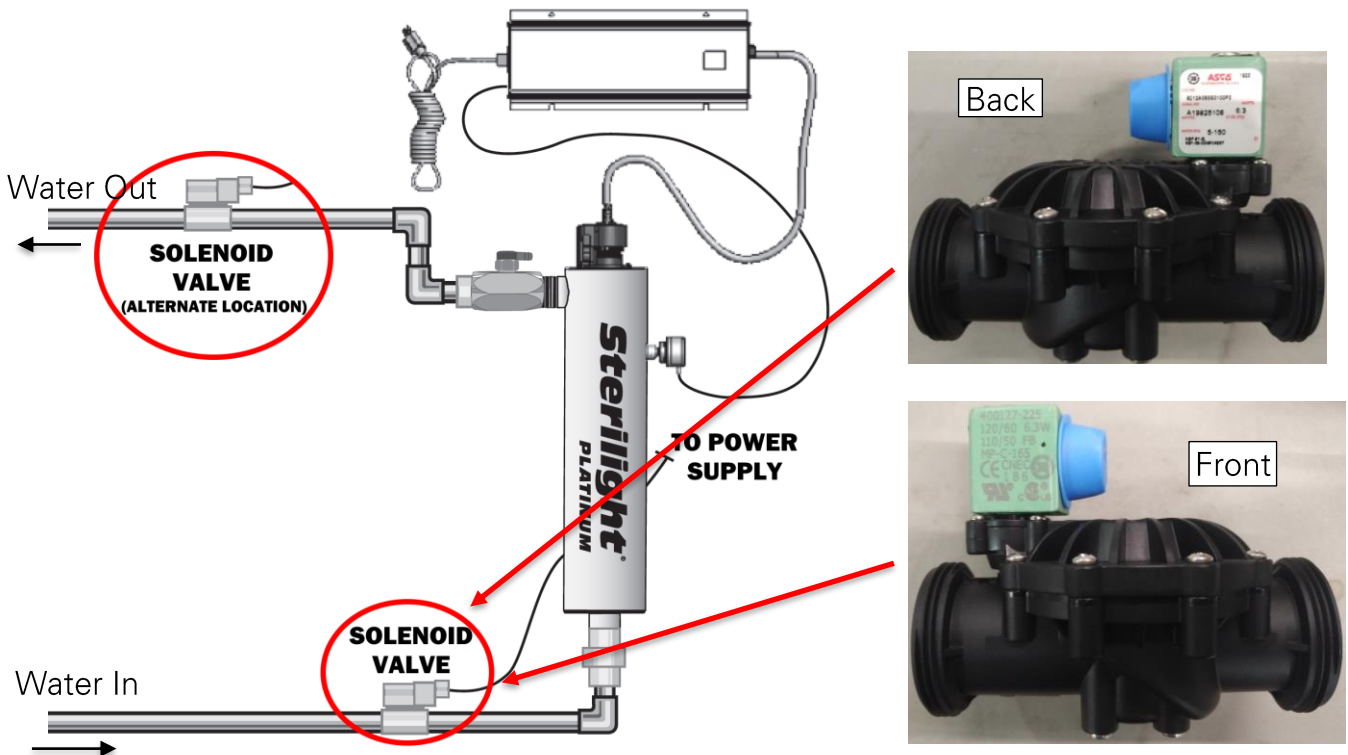
Please refer to below image to identify where the solenoid valve would typically be located within your VIQUA UV System. Valve may be installed on either inlet OR outlet of system. Affected valves will appear as shown.

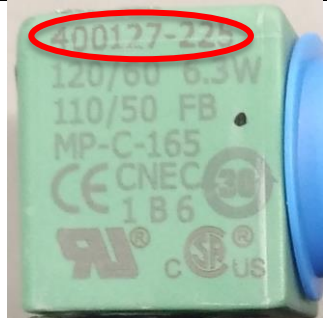
<p>Inspect the part number that appears on the front of the coil (circled in RED). Only coils with the part number beginning with 400127 are affected</p>

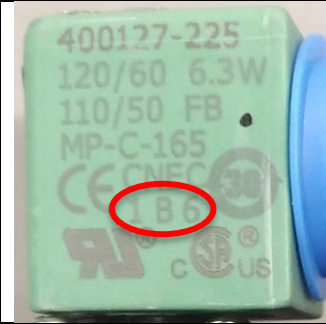
Inspect the date code on the coil (circled in **RED**).
Potentially affected units have coils marked with the following range of date codes:

1A3 through 5A2 (13th week through 52nd week of 2018)
0B1 through 0B8 (1st week through the 8th week of 2019)

If the date code on the coil is within the affected date code range, to avoid the risk of shock, do not re-connect power to or use the UV system until a replacement coil is installed.

Once the date code has been reviewed and the product has been identified within the impacted time period, the end user should follow the next steps:

- Contact the plumber / installer that installed the UV system, VIQUA will be providing a replacement coil which can be installed to fix the system
 - The plumber / installer will have replacement instructions and parts
- What happens if I do not know the plumber / installer that installed my UV system:
 - Please contact VIQUA Technical Support (technicalsupport@viqua.com or 1-800-265-7246 ext. 335)
 - VIQUA Technical Support will help locate a plumber / installer in your area that come and fix your system
 - VIQUA will ensure the plumber / installer has a replacement coil so the system can be fixed
